Re-roofing

Requirements Mean Radical Changes

By Richard E. Norris PE RRC D. Eng.

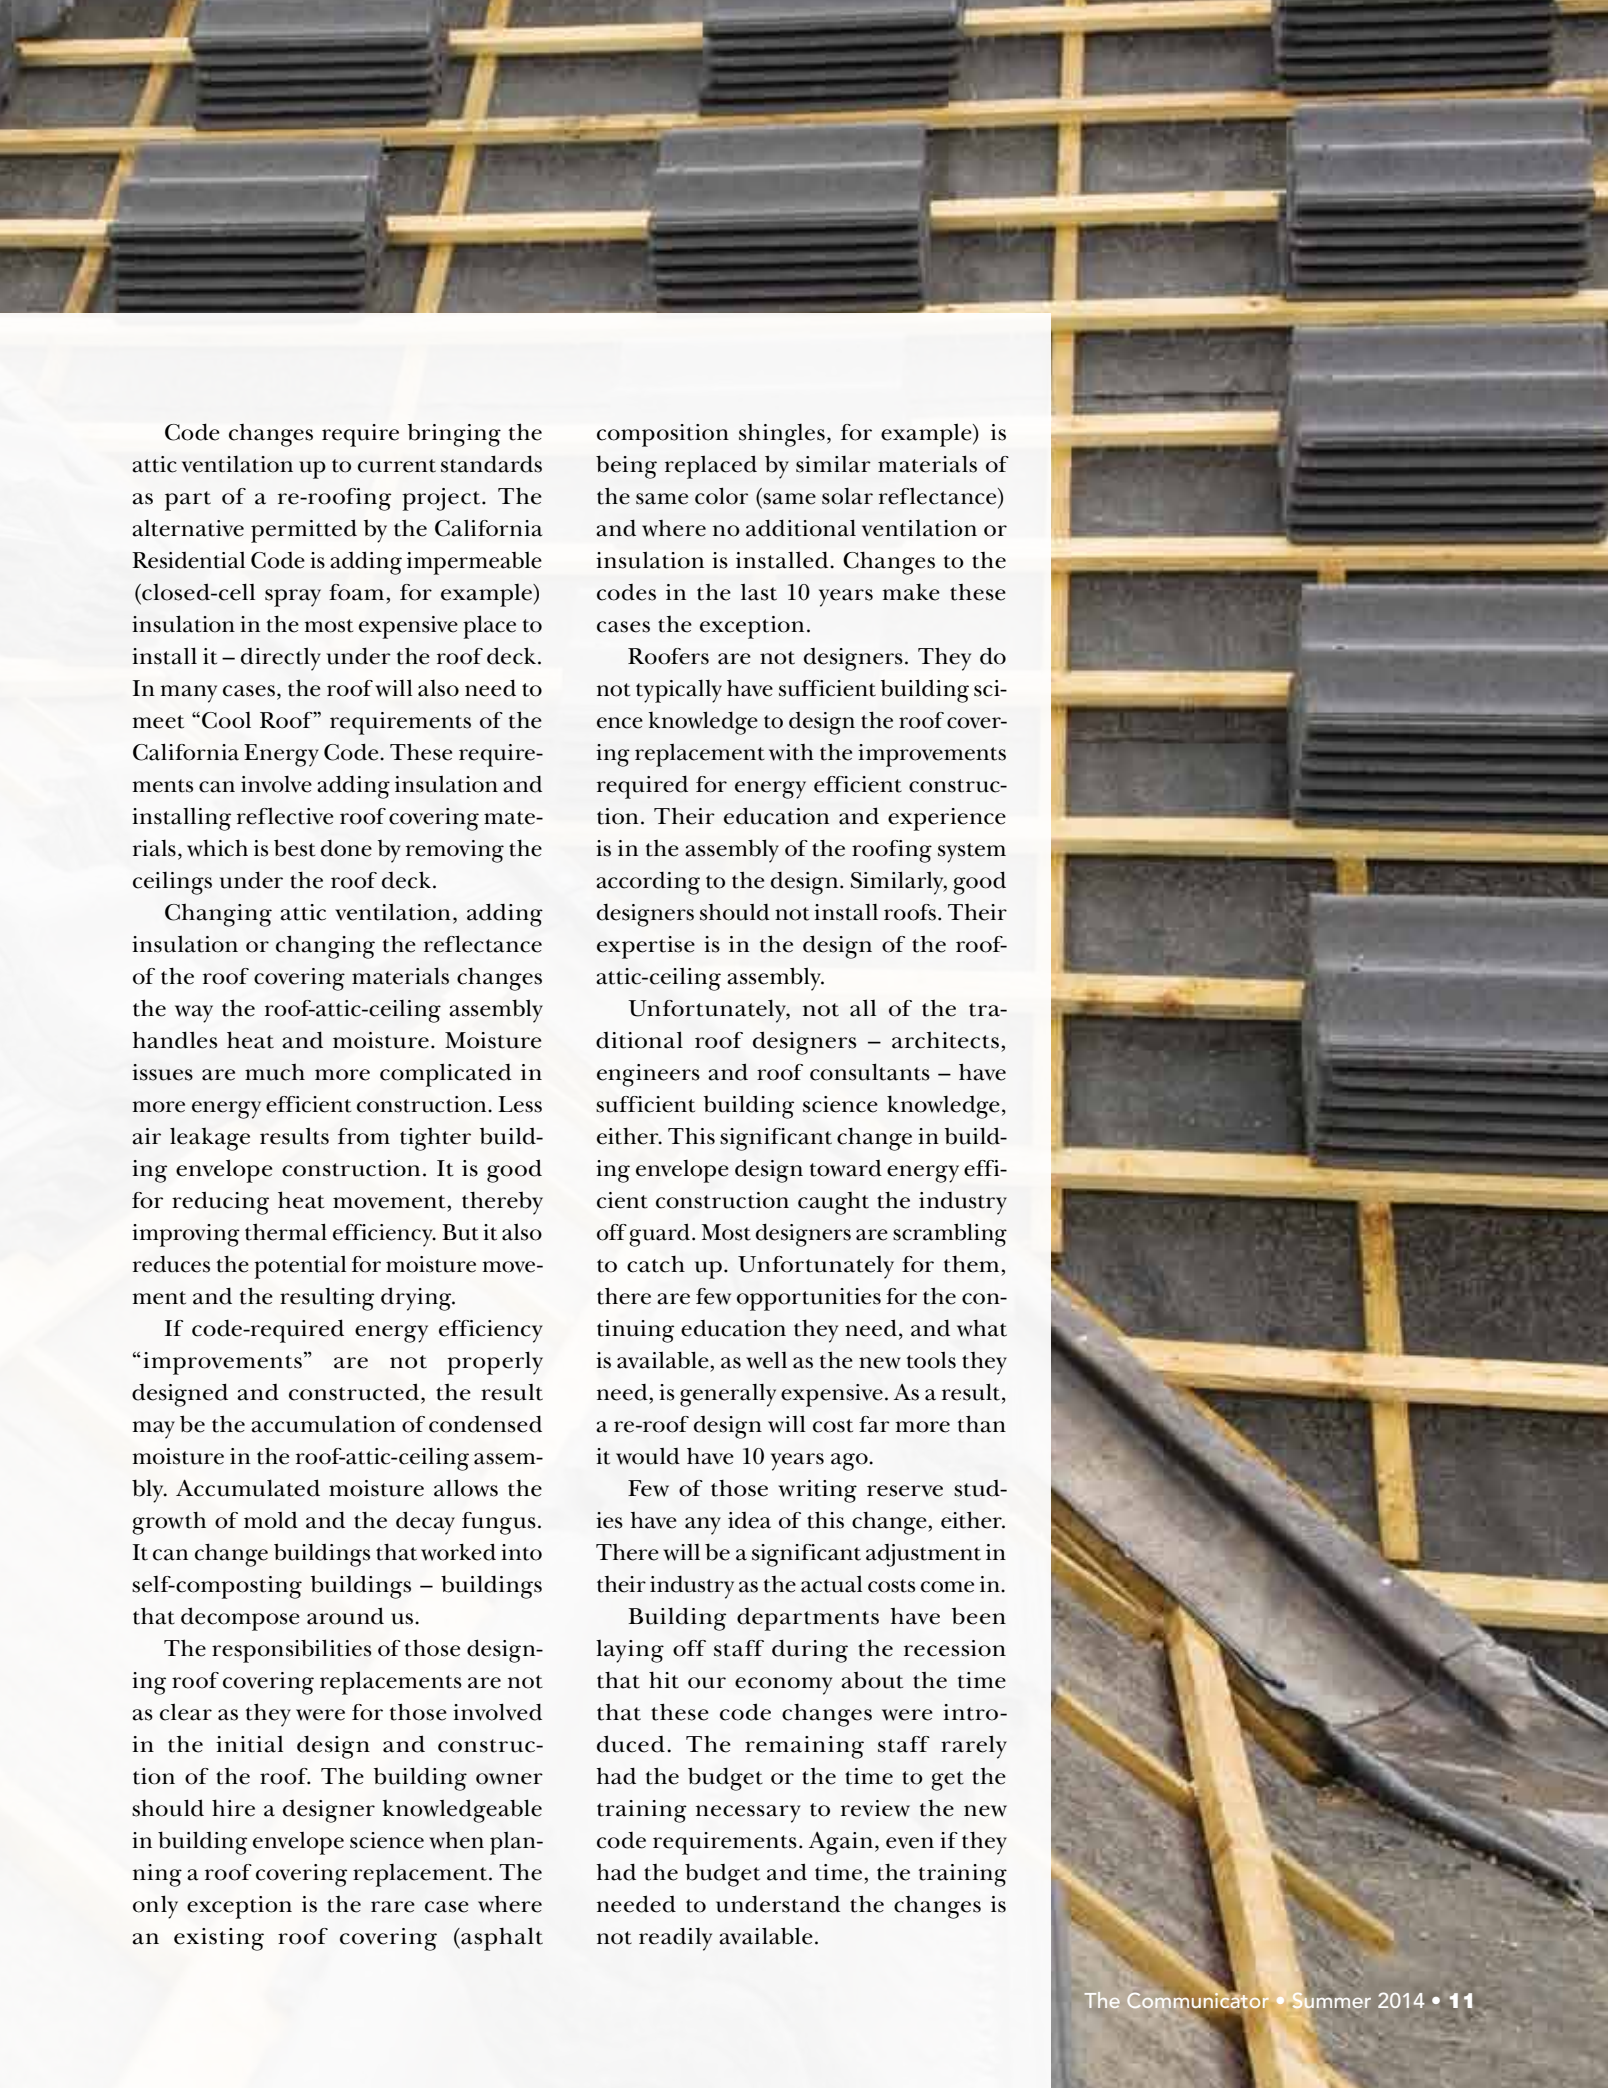
"REPLACING THE ROOF" is not just replacing the roof anymore. If you comply with all code requirements, you may end up converting your building into a compost pile. This is the extreme, of course, but in reality, lack of knowledge on the part of the owner, designer and contractor during re-roofing has turned more than one re-roofed condominium complex into self-composting buildings. Correcting this requires another re-roofing project, frequently less than 10 years later. Only this time, the roof, deck and insulation are being replaced; and, many of the rafters are either replaced or reinforced due to advanced wood decay (dry rot).

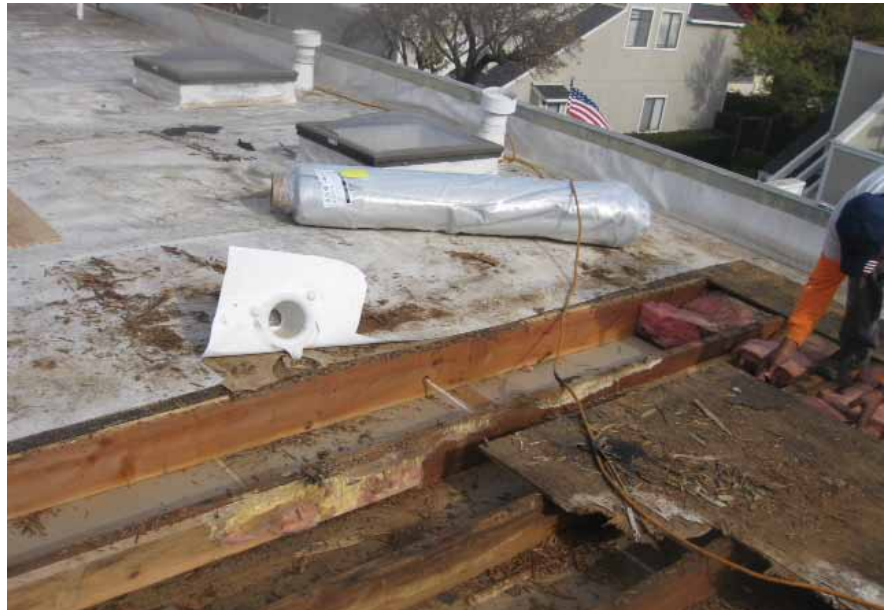
Pictured is one example of what happened at an HOA when a dark-colored roof was replaced without adding ventilation (now required) on a non-air conditioned condominium unit in the Southern part of the San Francisco Peninsula. The computer model shows that it would have still accumulated condensation, even if it had been ventilated. The roof system was rebuilt with closed-cell foam (in this case polyisocyanurate) insulation boards on top of a new roof deck and no ventilation.

Shortly after the existing built-up ("tar" and gravel) roof on this condominium complex was replaced with a new cool roof, the unit owner complained of water dripping into the unit through the ceiling on cold days. Most of the fiberglass batt insulation was removed before this photograph was taken. It had a lot of mold in it. Some of the roof deck and the vertical faces of the rafters have decay fungus white fibers (mycelia mats) covering them, a sure sign that there is advanced decay within the wood. The plywood roof deck was severely deteriorated. In places, it was so badly decayed that it was easy to remove the plywood by the handful. ■

Some of the code requirements are unnecessary or even contradictory. It would be easy for a contractor to unknowingly convert an existing structure into a self-composting building, even if he follows (and perhaps because he follows) the requirements of the codes. Most contractors understand how to install the roofing system, but few understand the building science required to avoid these pitfalls. Building owners who rely on well-meaning contractors may wind up with extensive wood decay in the roof deck and framing and mold in the insulation and on the roof framing, roof deck and roofing.

Re-roofing may become necessary again in a few years, only this time they will also be replacing the roof deck and reinforcing or replacing the rafters.
